Most of my flying to date has been off of water. I now have 29.7 hours on the hour meter and in that time have made 82 water landings and 2 land landings. Here in Seattle there has been a lot of variation in water conditions in the past 10 months I've been testing my Osprey. I have landed in a 38 mile wind and 2 foot waves.

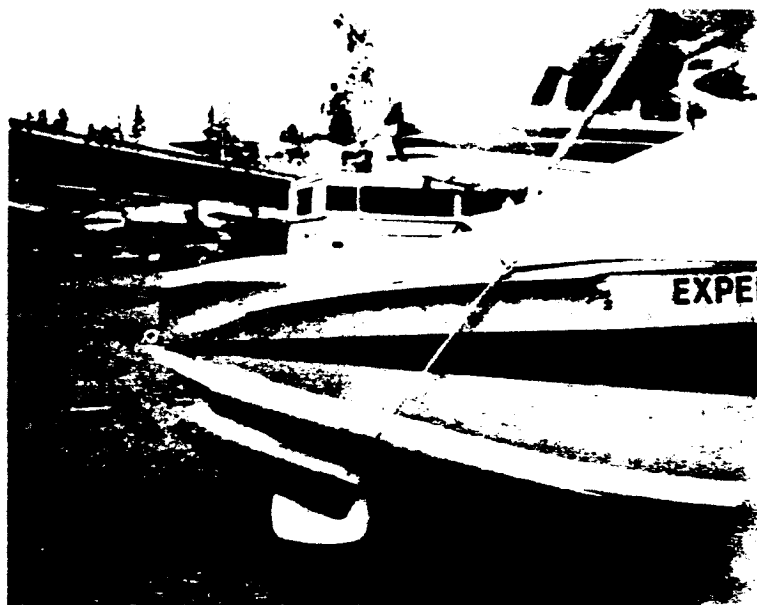
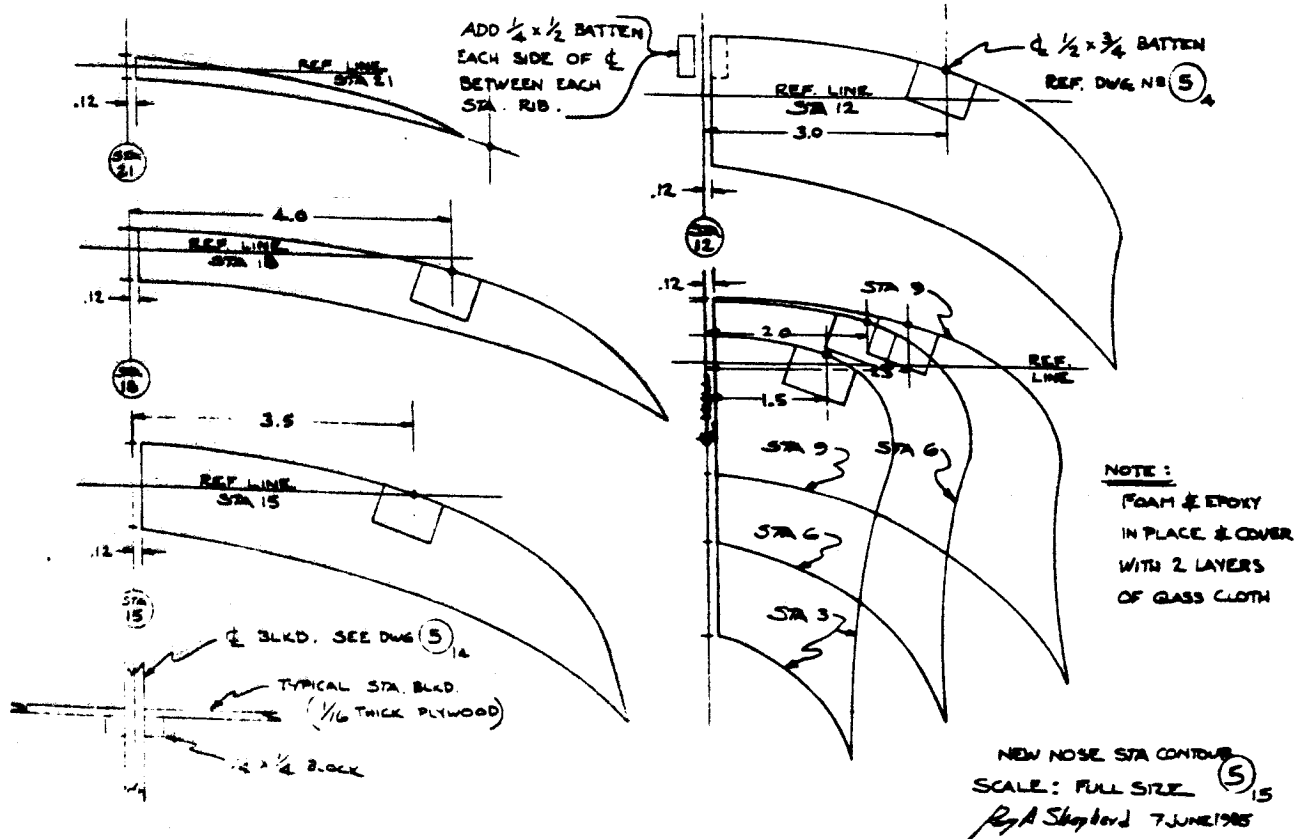
The original shape of the top of the nose is conducive to sending a wave of water over the windshield every small wave you encounter when taxiing at low speed before the hull lifts up on the step. This also gives you a lot of problem when turning to taxi down wind when there is above 5 miles wind velocity. To correct this I've modified the nose shape as shown on the enclosed drawings. This change seems to correct most or all the water over the windshield problem and the spray thru the propeller problem seems to be under control with the addition of the three foot long aluminum extrusions to each side of the forward spray rail area. The aluminum extrusion used is originally intended to be a step edge and carpet retainer. As far as the built in instruments show there seems to be no change in flight performance with the new nose.

P.S. (9-10-85) I now have 94 water landings and 40.1 hours on the Osprey. Just completing my first annual inspection and the FAA has given me an unlimited clearance license. The new nose almost completely eliminates the water over the windshield problems encountered with the original shape.
